Inspector General

Assessment of Electrical Safety In Afghanistan

July 24, 2009

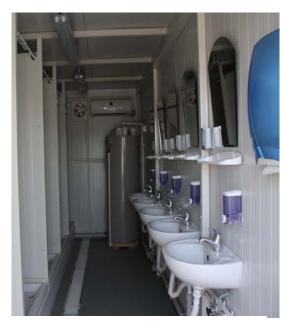
Figure 15. Inside view of a typical ablution unit

We observed that new ablution units at Kandahar Airfield were being re-wired to meet NEC 2008. The assessment team's subject matter expert concluded that there may be a timelier and more cost effective alternative to meet NEC other than a complete re-wiring. In the opinion of the subject matter expert, replacing the electrical panel in lieu of complete rewiring may be a solution that could bring the Ablution units into compliance with NEC 2008.

According to the assessment team's electrical subject matter expert, these units were wired using Residual Current Device, the European equivalent of ground fault current

12. We recommended that USFOR-A determine if replacing the electrical panel, in lieu of complete re-wiring, will bring the ablution units in compliance with NEC 2008.

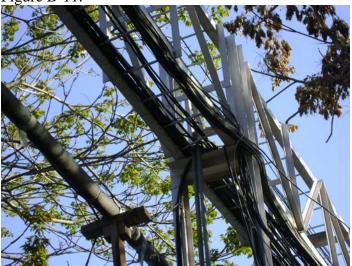
Figure B-11.

Figure B-11 was taken at Camp Eggers. This is a photo of an overhead raceway for cables to protect them from getting stepped on or run over.

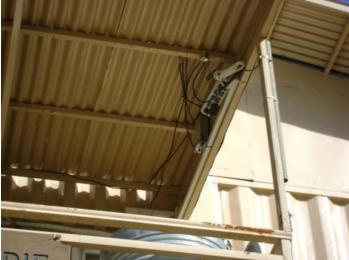
Figure B-12 was taken outside of a barracks at Camp Eggers. The photo shows power strips rated for indoor use being used outside.
